**Fusion3**

# **EDGE 3D Printer**

## **MAINTENANCE: BOWDEN TUBE SERVICE & REPLACEMENT**

**Revision 3/20/2022**

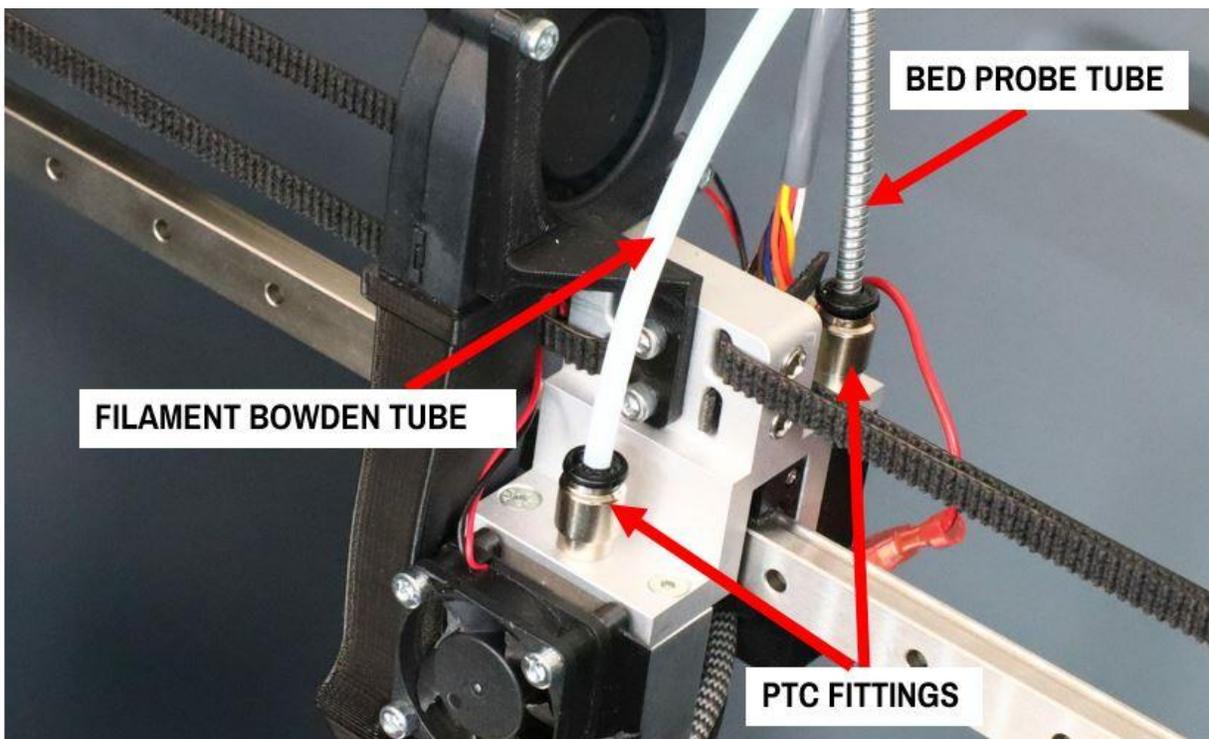
EDGE has two flexible tubes that run up to the print head assembly:

- **Bowden Tube:** A semi-opaque plastic (PTFE) tube that runs from the outlet of the extruder to the top of the print head
- **Bed Probe Tube:** A metal spiral-wound tube that runs from the bed probe motor to the top of the bed probe body on the x carriage assembly.

Both of these are retained by push-to-connect (PTC) fittings on both ends.

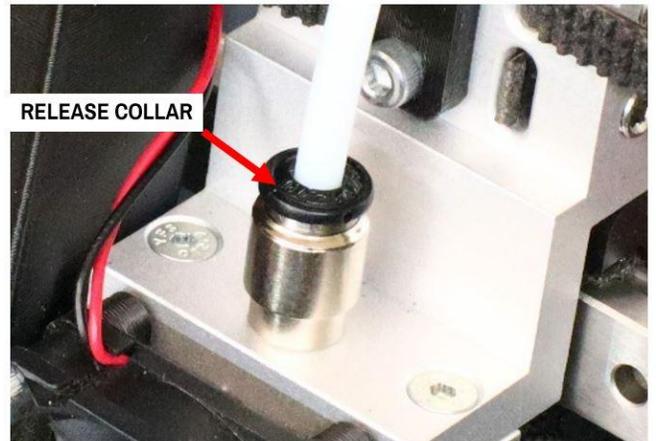
1. **Do not** try to remove the tube while it's under tension. If it is, gently push the tube into the fitting as you do the next steps.
2. Locate the release collar on the fitting. This is a black ring around the top of the fitting that stands up slightly.

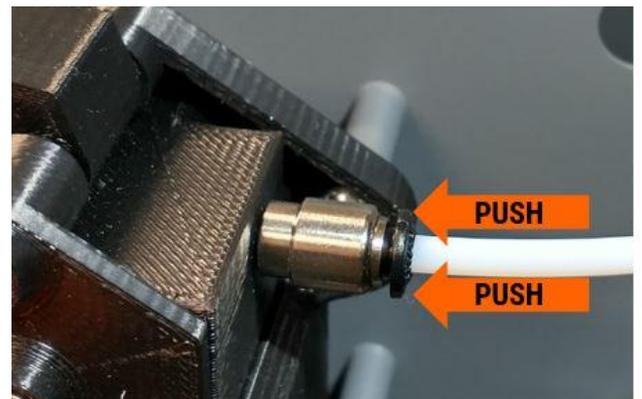
3. Press the release collar into the fitting body and hold it down.

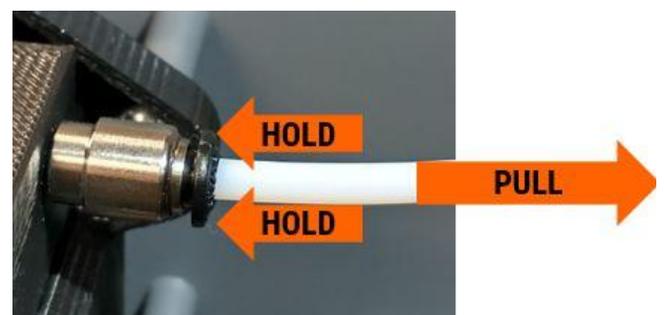
4. Gently pull on the tube to remove it from the fitting. If it will not come out, try twisting it slightly or pushing it further into the PTC body while still holding down the release collar.

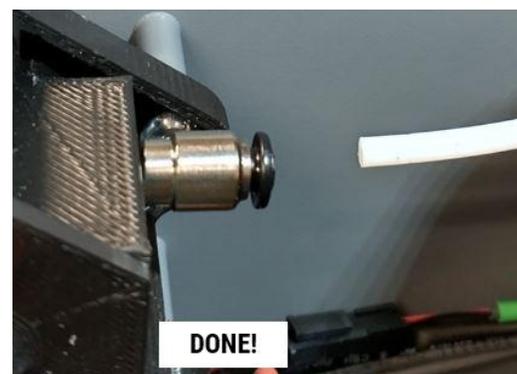
5. The tube should now come out of the fitting easily.

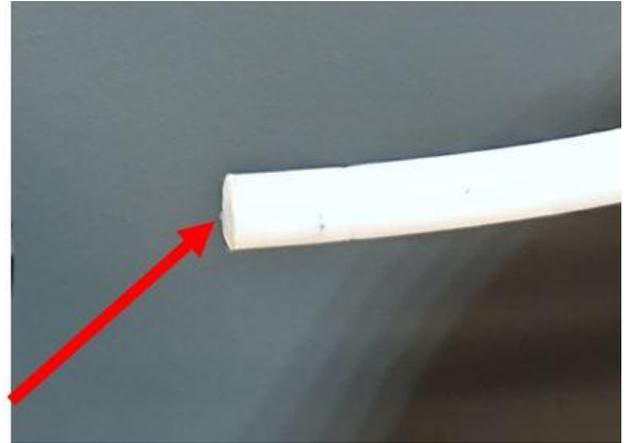
1. Make sure the end of the tube is cut square and cleanly. If you purchased the tube from Fusion3 it will come pre-prepped.
  - a. (PTFE filament tube) It should be cut with a razor blade or other very sharp knife. **Do not use** something like scissors or diagonal cutters or wire cutters, as this will deform the tube.
  - b. (Metal spiral probe tube) It should be cut with a cutoff wheel and cleaned up with a hand file. Again, do not use any cutting implement that might deform or crush the tube.

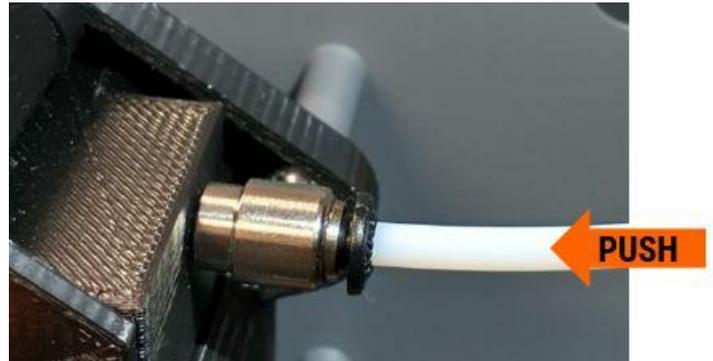
2. Press the tube straight into the PTC fitting until it bottoms out. You should feel two discrete detents. If you only feel one, the tube is not fully inserted.

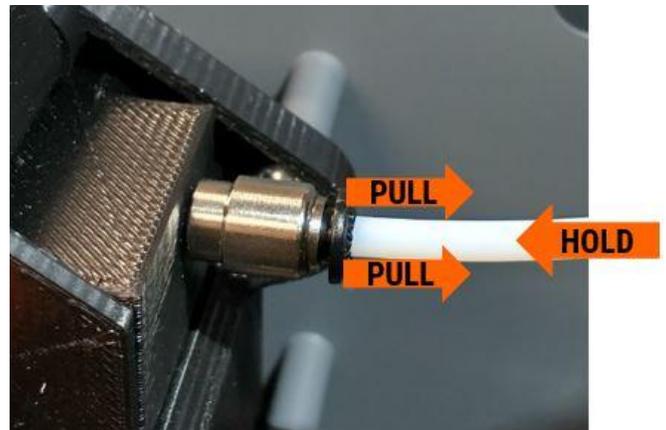
3. Pull up gently on the locking collar and push the tube down again to make sure it's firmly seated in the bottom of the fitting.

4. The tube is installed correctly when you can feel and see less than 0.25mm of play between the tube and fitting when you gently push and pull on the tube.
